HERITAGE SURVEY AND EVALUATION FORM

MUNICIPAL ADDRESS: 14 Elgin Street	BUILDING NAME:		
LEGAL DESCRIPTION: Elgin Street	LOT: 18B	BLOCK:	PLAN:

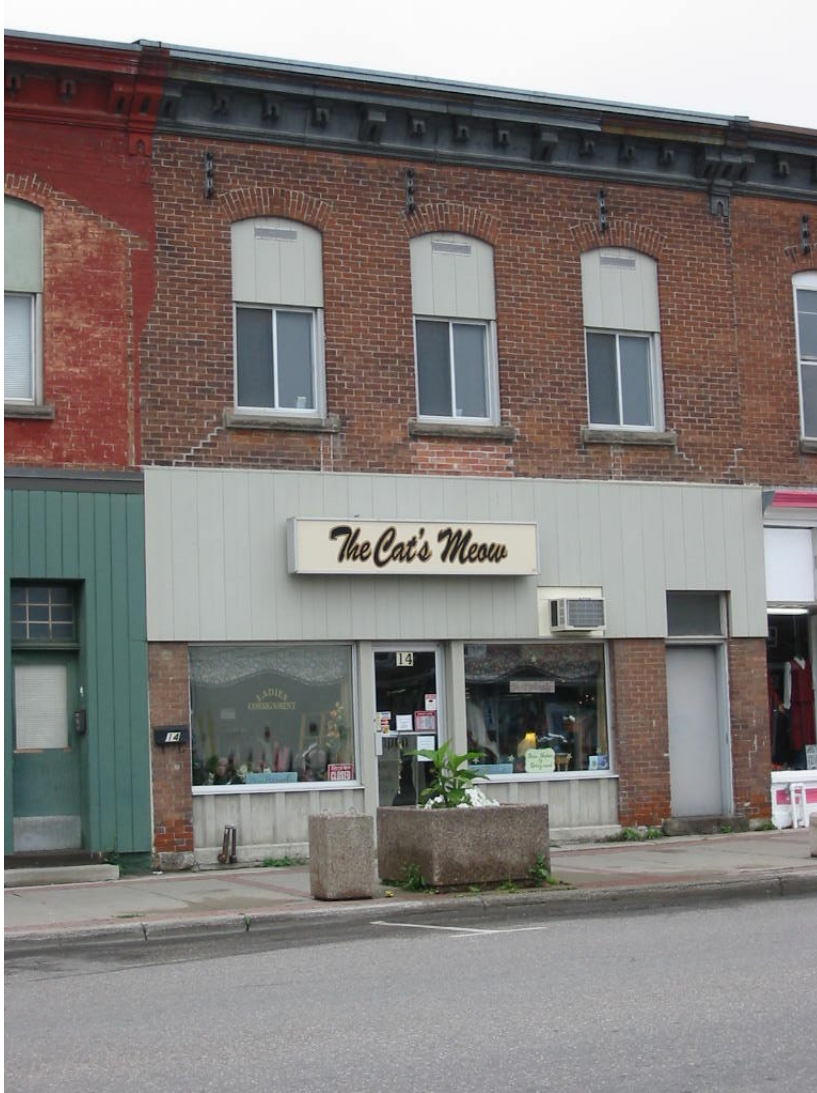
SOURCE: Carol Ruddy
DATE: summer 2006

Two-storey, rectangular plan, flat-roofed reddish/ brown brick structure; three rectangular window openings with voussoirs and masonry sills on the second level have been partially filled in; the centre window opening appears to be a door opening that has been bricked in; storefront has been extensively altered and is clad in metal siding; storefront has display windows and door that are contemporary in style; store entrance is centred between the display windows; store is one riser above grade; on the right side of the storefront there is another door with transom light that gives access to the second floor of the building; portions of the storefront are clad in reddish/brown brick; pressed metal building cornice with brackets; backlit sign box located above store entrance.

Original window openings (and possibly a door opening) on the second floor partially filled in; the storefront has been altered extensively.

Extensive alterations to storefront and second storey windows and door. Brick cladding and building cornice contribute to streetscape character.

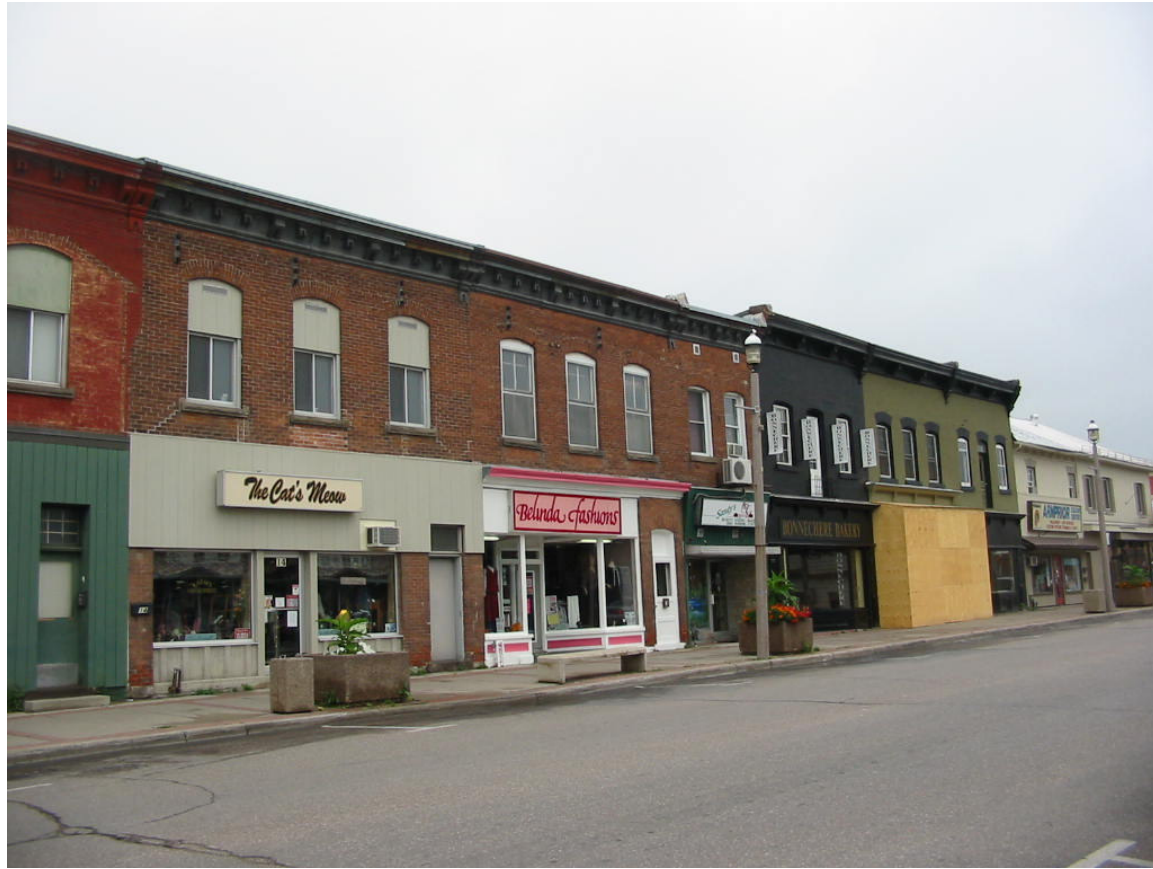
SOURCE: Carol Ruddy
DATE: summer 2006

A contributing element in the streetscape character.

The building cornice, lug sills, voussoirs and brick cladding contribute to the heritage character of the streetscape.
