# HERITAGE SURVEY AND EVALUATION FORM

MUNICIPAL ADDRESS: 18 Elgin Street	BUILDING NAME: Union Block		
LEGAL DESCRIPTION: Elgin Street	LOT: 18C	BLOCK:	PLAN:

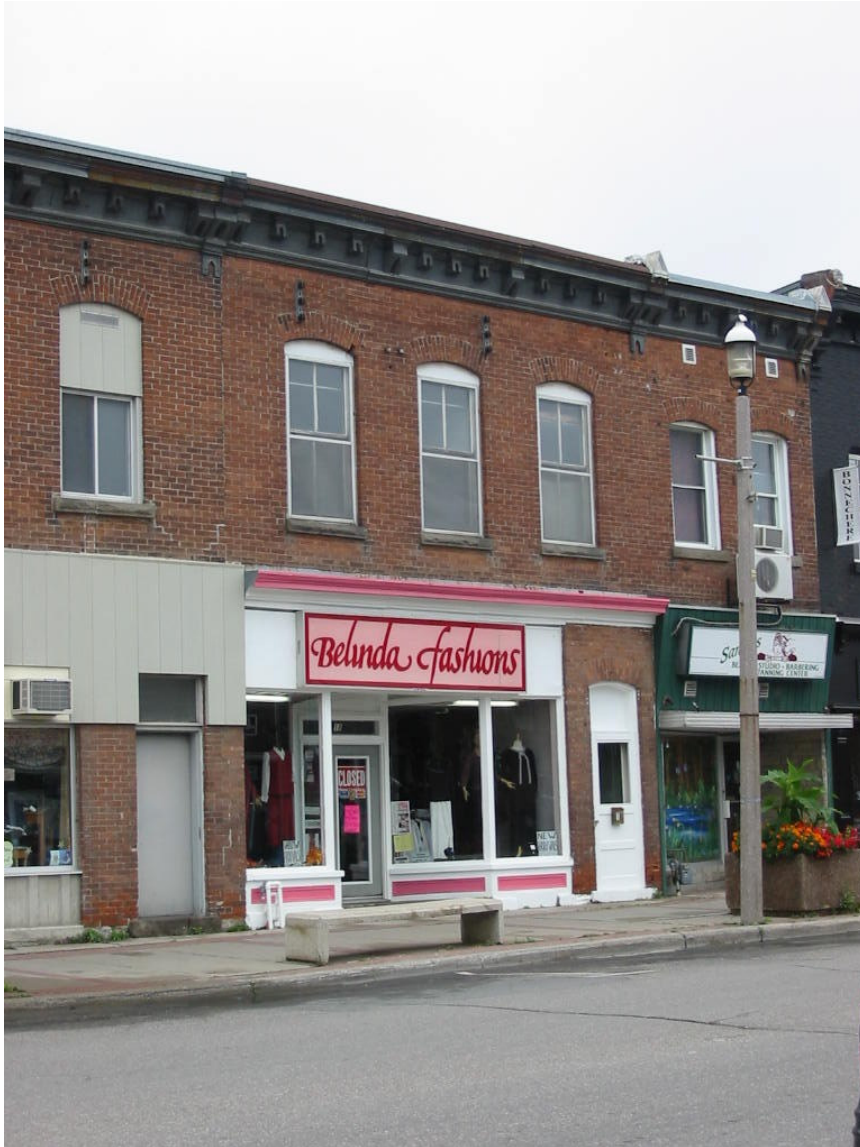
SOURCE: Carol Ruddy  
DATE: summer 2006

Two-storey, rectangular plan, flat-roofed reddish/brown brick structure; three rectangular window openings with voussoirs and masonry sills on the second level; original window openings have been maintained except for inserts that fill in the area under the voussoirs; storefront generally maintains original design with large display windows, recessed entry, base panel, sign panel and storefront cornice; pressed metal building cornice with brackets; on the right side of the storefront there is another door with transom light and voussoirs that gives access to the second floor of the building; sign box centred over the display windows; storefront door has a transom and sidelight.

Original window openings generally maintained; replacement windows; storefront has generally maintained its original design, however the door has been replaced and the transom over the apartment entrance has been filled in.

Storefront and second storey windows generally have good integrity. Brick cladding, recessed storefront entry and projecting building cornice contribute to streetscape character.

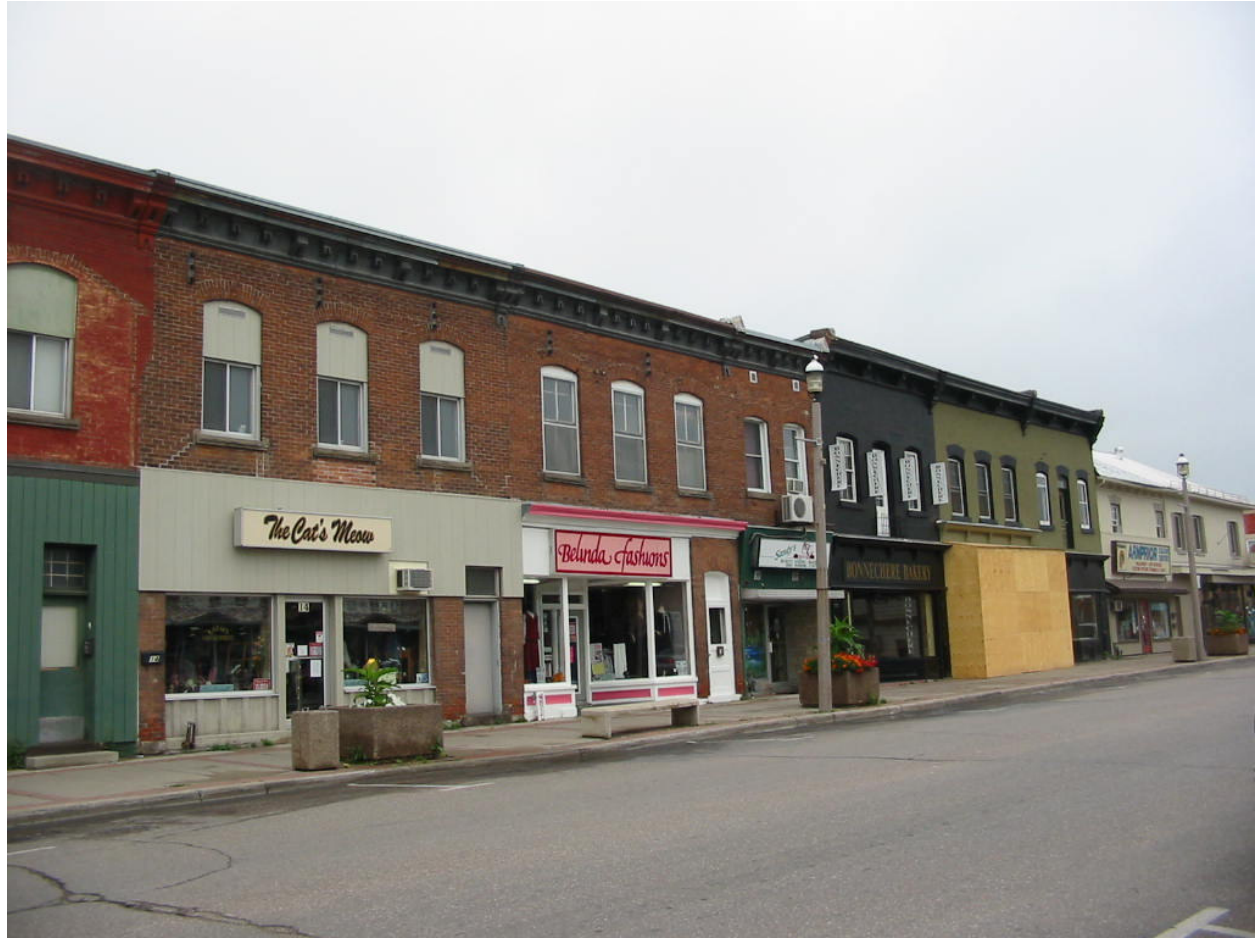
SOURCE: Carol Ruddy  
DATE: summer 2006

A compatible element in the streetscape.

The brick cladding, voussoirs, lug sills and cornice with brackets contribute to the streetscape character.
