HERITAGE SURVEY AND EVALUATION FORM

MUNICIPAL ADDRESS: 22 Elgin Street	BUILDING NAME:		
LEGAL DESCRIPTION: Elgin Street South	LOT: 20 infill	BLOCK:	PLAN:

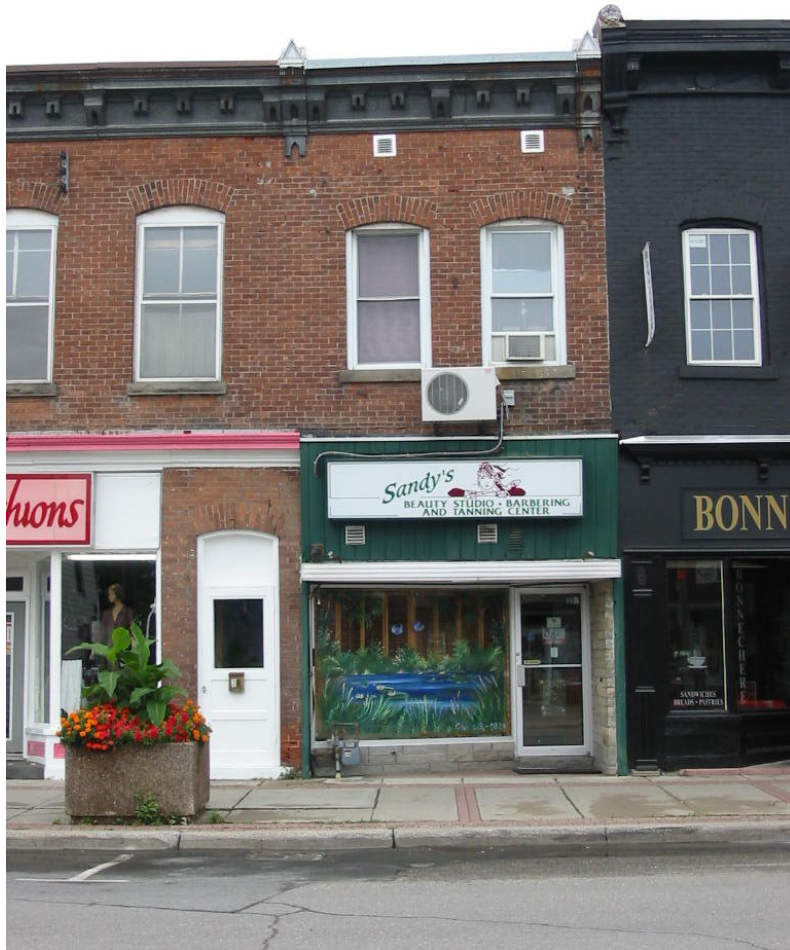
SOURCE: Carol Ruddy
DATE: summer 2006

Narrow, two-storey, rectangular plan, flat-roofed reddish/brown brick structure; two rectangular window openings with voussoirs and masonry sills on the second level; original window openings have been maintained except for inserts that fill in the area under the voussoirs; storefront has display windows and door that are contemporary in style with an entrance on the right side of building; painted panel over display windows extends to height of storefront cornice on 18 Elgin Street; sign box centred over the display windows; pressed metal, projecting building cornice with brackets is identical to 12, 14 and 18 Elgin Street.

Vernacular Italianate commercial building; the projecting building cornice with brackets and the voussoirs are Italianate-inspired details.

Extensive alterations to storefront; original window openings generally maintained; replacement windows and doors.

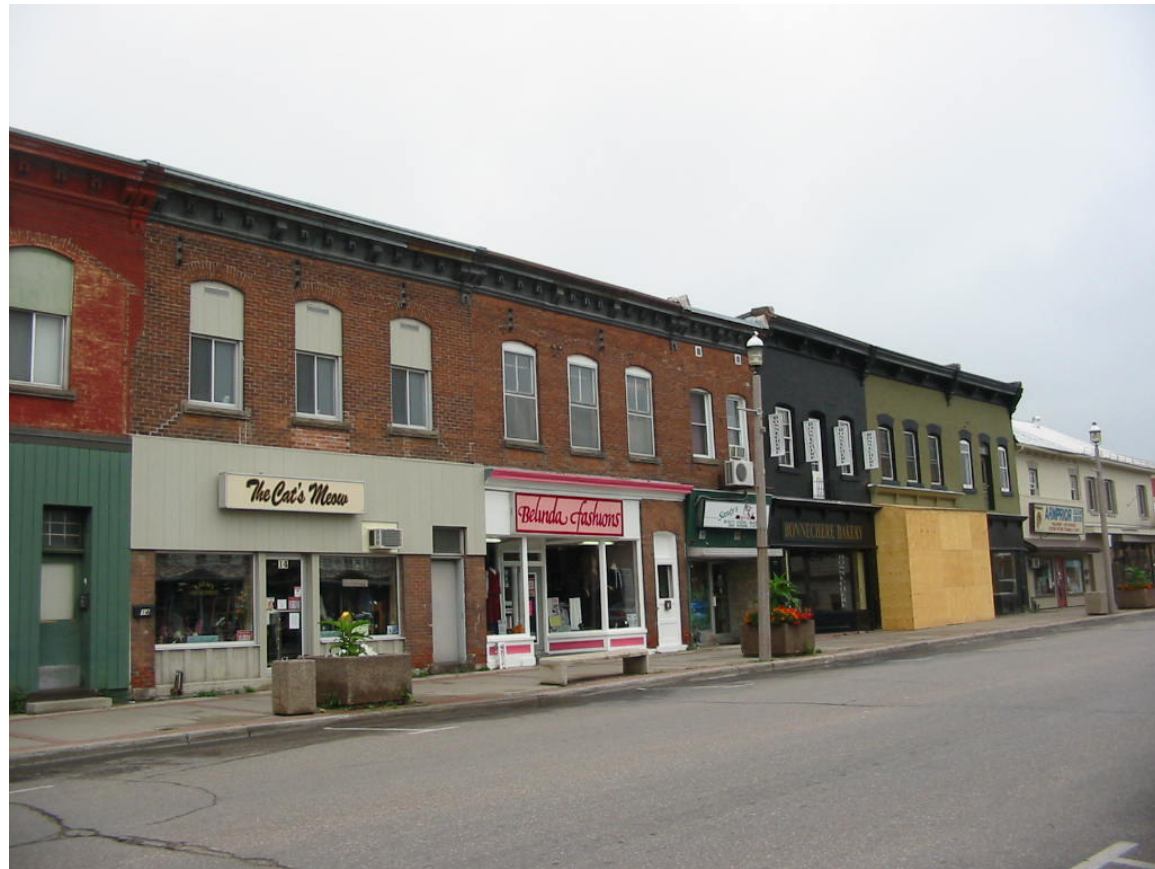
A compatible element in the streetscape.

The brick cladding, voussoirs, building cornice with brackets and lug sills contribute to the streetscape character; while adding interest and being compatible with the typical storefront width in the streetscape, the narrow width of this storefront is unusual.
