HERITAGE SURVEY AND EVALUATION FORM

MUNICIPAL ADDRESS: 32 Elgin Street	BUILDING NAME:		
LEGAL DESCRIPTION: Elgin Street South	LOT: 22 East	BLOCK:	PLAN:

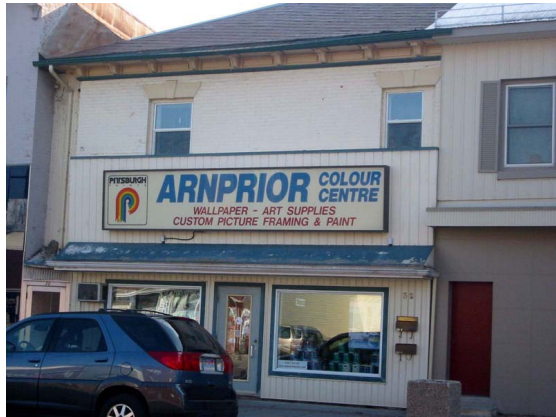
SOURCE: Carleton University
DATE: fall 2003

Two-storey, rectangular plan, hipped roof, structure; brackets under the eave of the hip roof; brick cladding, painted; two rectangular window openings on the second floor with decorative keystone; storefront on ground level has been reworked, with the top of the storefront covering a portion of the second storey windows; storefront is clad in vertical siding; storefront has a shallow shed awning with large display windows either side of the centrally located door.

Storefront has been completely reworked; replacement doors and windows.

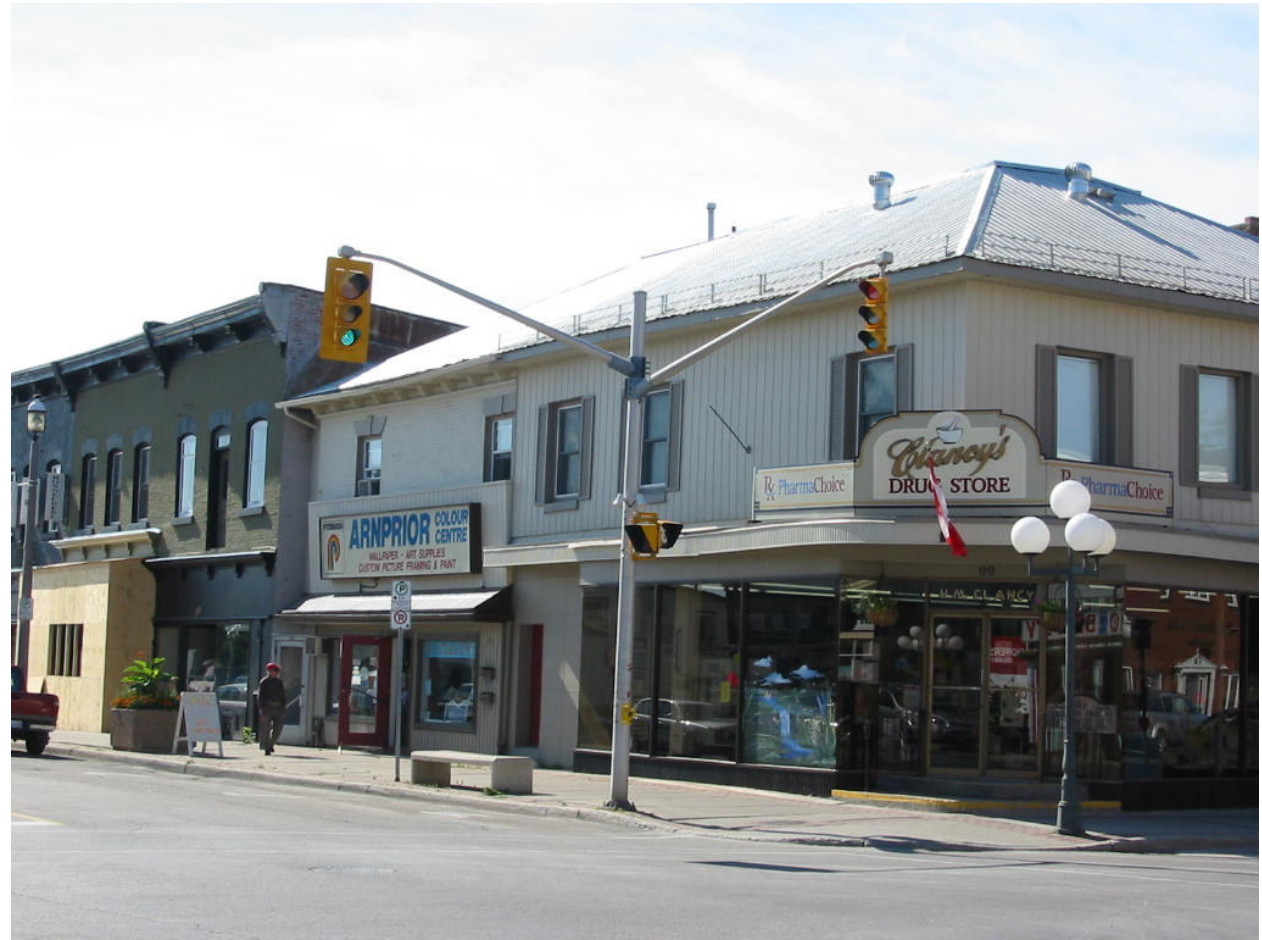
SOURCE: Carol Ruddy
DATE: summer 2006

A compatible element in the streetscape.

The keystones over the second storey window heads and the brackets below the eaves contribute to the heritage character of the streetscape.
