HERITAGE SURVEY AND EVALUATION FORM

MUNICIPAL ADDRESS: 124 John Street	BUILDING NAME: former Farmer Brothers Building		
LEGAL DESCRIPTION: John Street West	LOT: 3A	BLOCK:	PLAN:

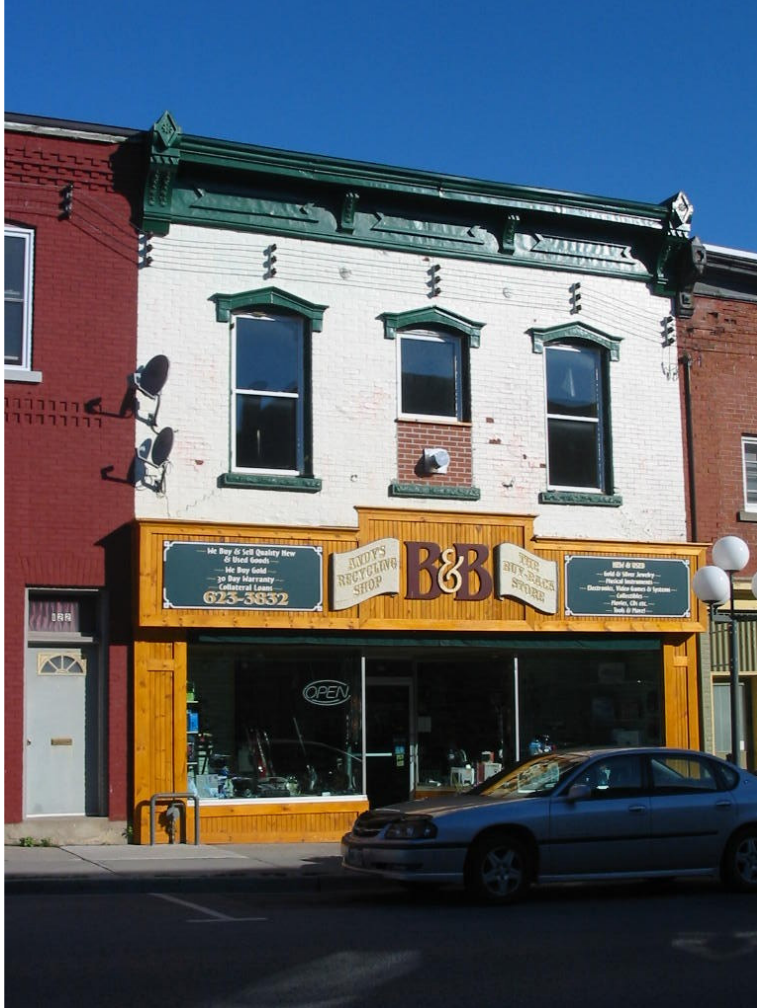
SOURCE: Carol Ruddy
DATE: July 2007

Two-storey, rectangular plan, flat-roofed red brick structure; three rectangular window openings, with two over two sashes with window hoods on the second level; middle window opening has been partially bricked in; window openings have lug sills; storefront has large display windows and recessed entry; large sign panel over the display windows with a backlit sign box; building cornice with brackets and decorated frieze board.

Replacement storefront windows and door.

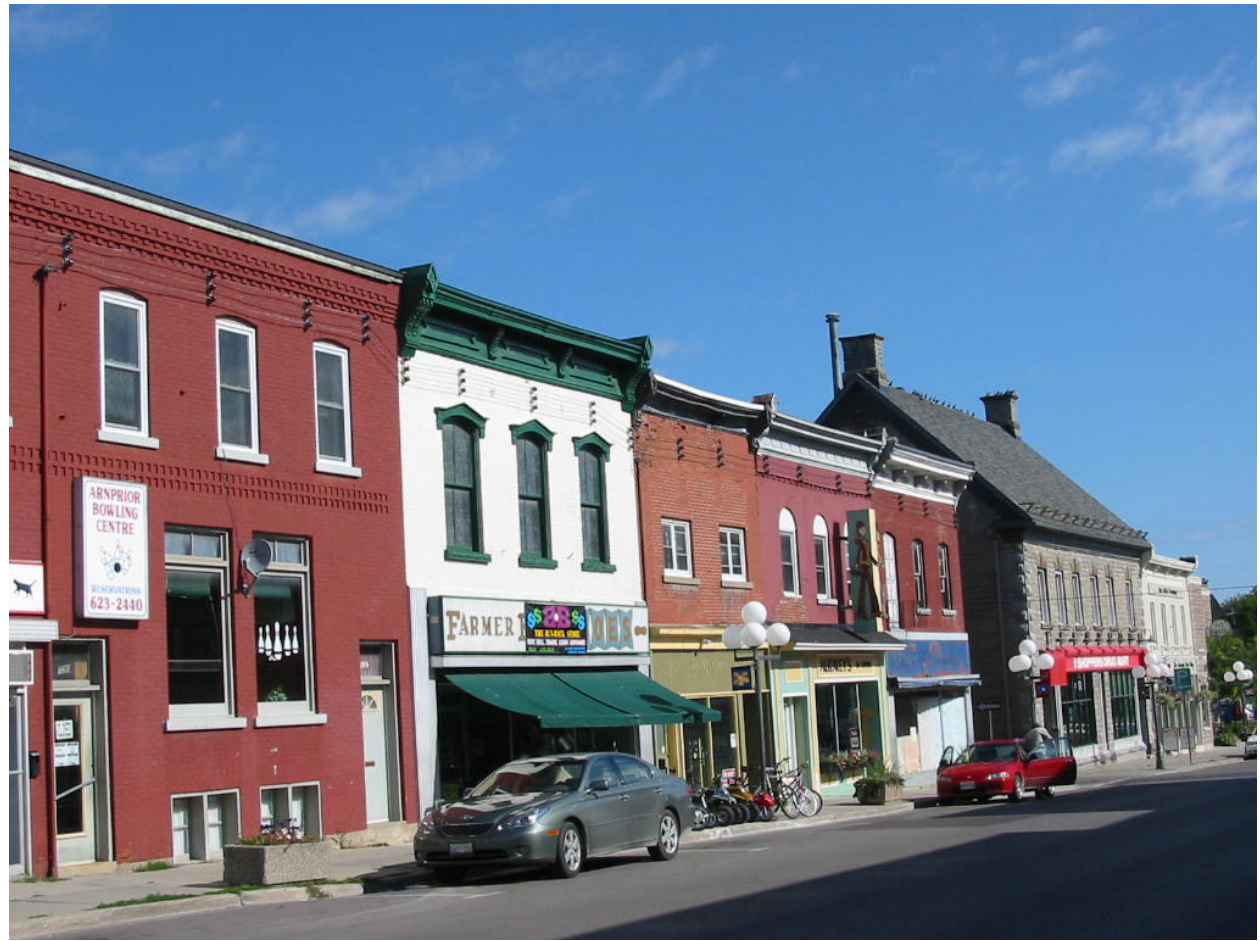
SOURCE: Carol Ruddy
DATE: summer 2006

A compatible element in the streetscape.

The fine building cornice, brick cladding, window hoods, lug sills and the storefront organization contribute to the streetscape character.
