HERITAGE SURVEY AND EVALUATION FORM

MUNICIPAL ADDRESS: 128 John Street	BUILDING NAME: former B and B Buyback Building		
LEGAL DESCRIPTION: John Street West	LOT: 3B	BLOCK:	PLAN:

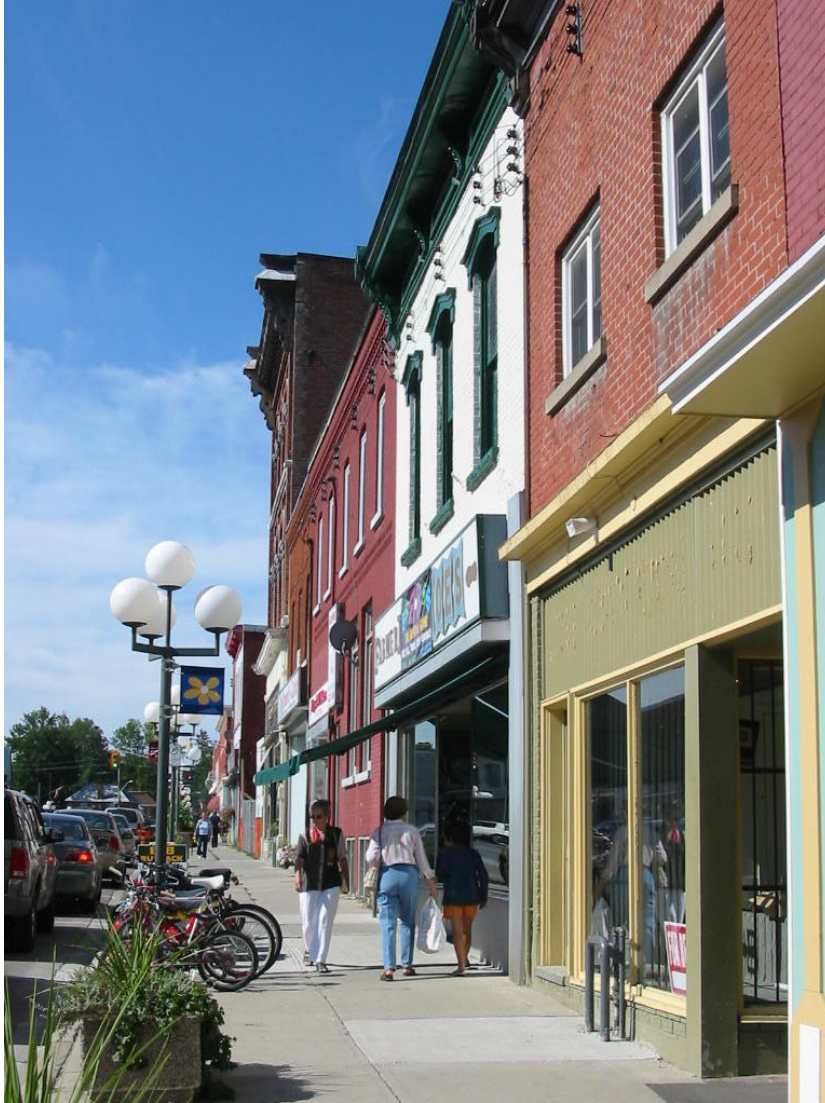
SOURCE: Carol Ruddy
DATE: summer 2006

Two-storey, rectangular plan, flat-roofed red brick structure; recessed storefront entry with base panel and sign panel above the display windows; two window openings on the second level, partially bricked in; building cornice with end brackets.

Storefront has been reworked, having contemporary display windows and door; second storey windows have been partially bricked in.

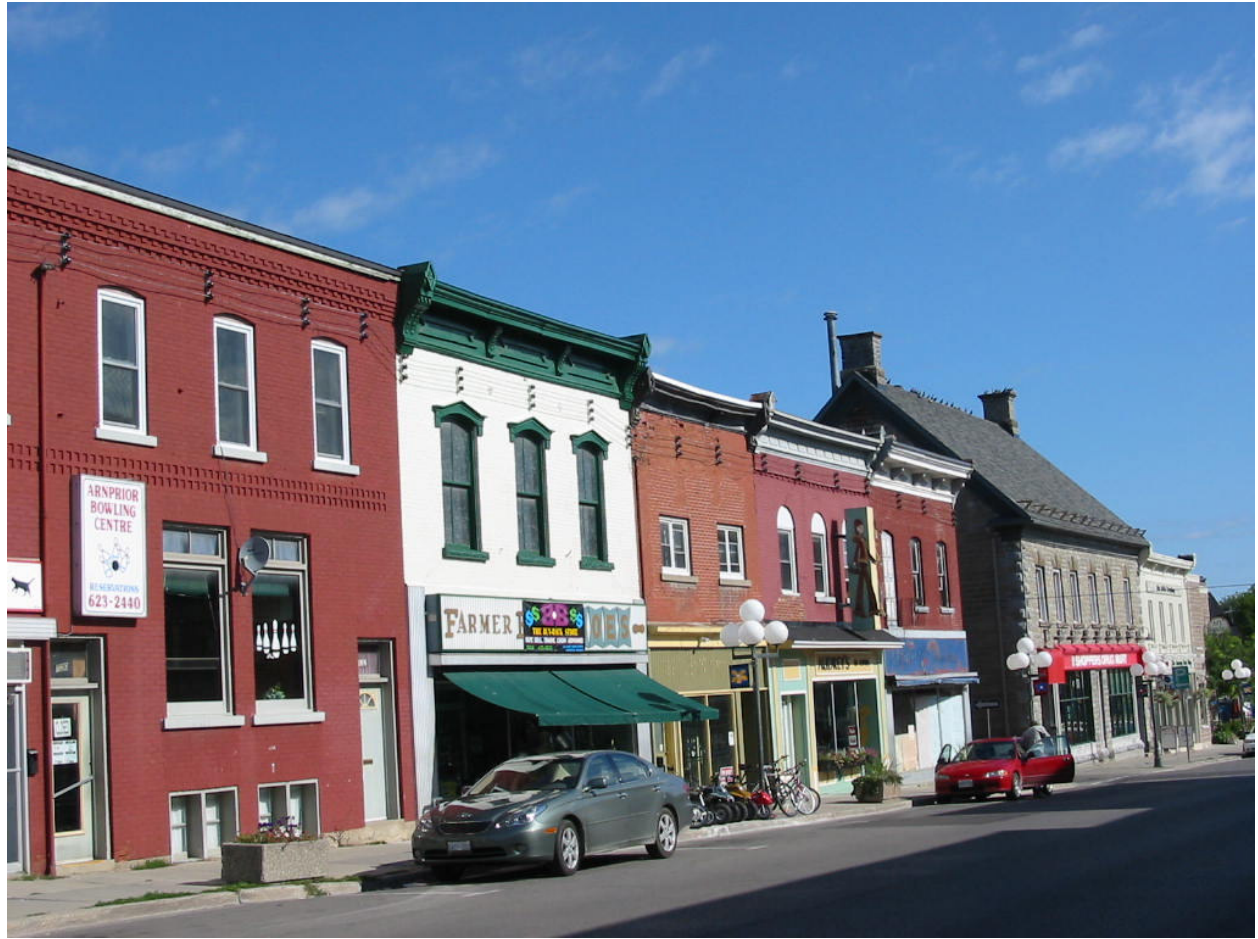
SOURCE: Carol Ruddy
DATE: summer 2006

A compatible element in the streetscape.

The brick cladding, building cornice and storefront organization contribute to the streetscape character.
