HERITAGE SURVEY AND EVALUATION FORM

MUNICIPAL ADDRESS: 135 John Street	BUILDING NAME:		
LEGAL DESCRIPTION: John Street East	LOT: 4 - A	BLOCK:	PLAN:

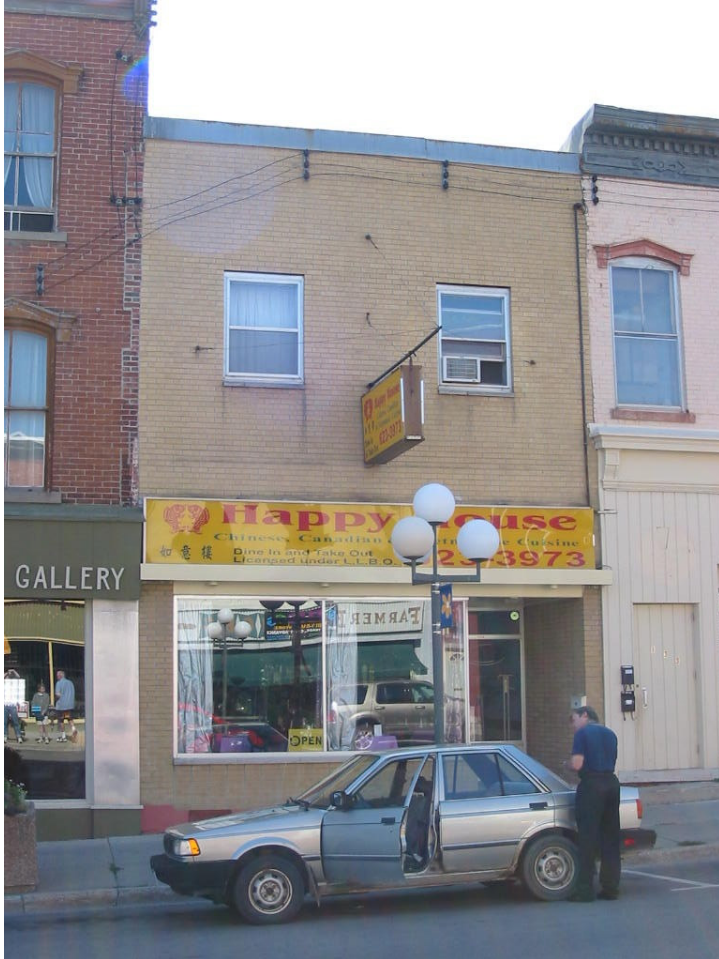
SOURCE: Carol Ruddy
DATE: summer 2006

Two-storey, rectangular plan, flat-roofed brick structure; two, small rectangular window openings with concrete sills; the storefront has large display windows and a recessed entry; base panel is clad in brick that appears to be original to the date of construction; sign panel over the display window with a backlit sign box; wide strip of flashing caps the building; projecting, bracket mounted sign just below bottom edge of second-storey windows.

Original window openings and storefront design maintained.
