# HERITAGE SURVEY AND EVALUATION FORM

MUNICIPAL ADDRESS: 137 John Street	BUILDING NAME: Robertson's Furniture		
LEGAL DESCRIPTION: John Street East	LOT: 4 - B	BLOCK:	PLAN:

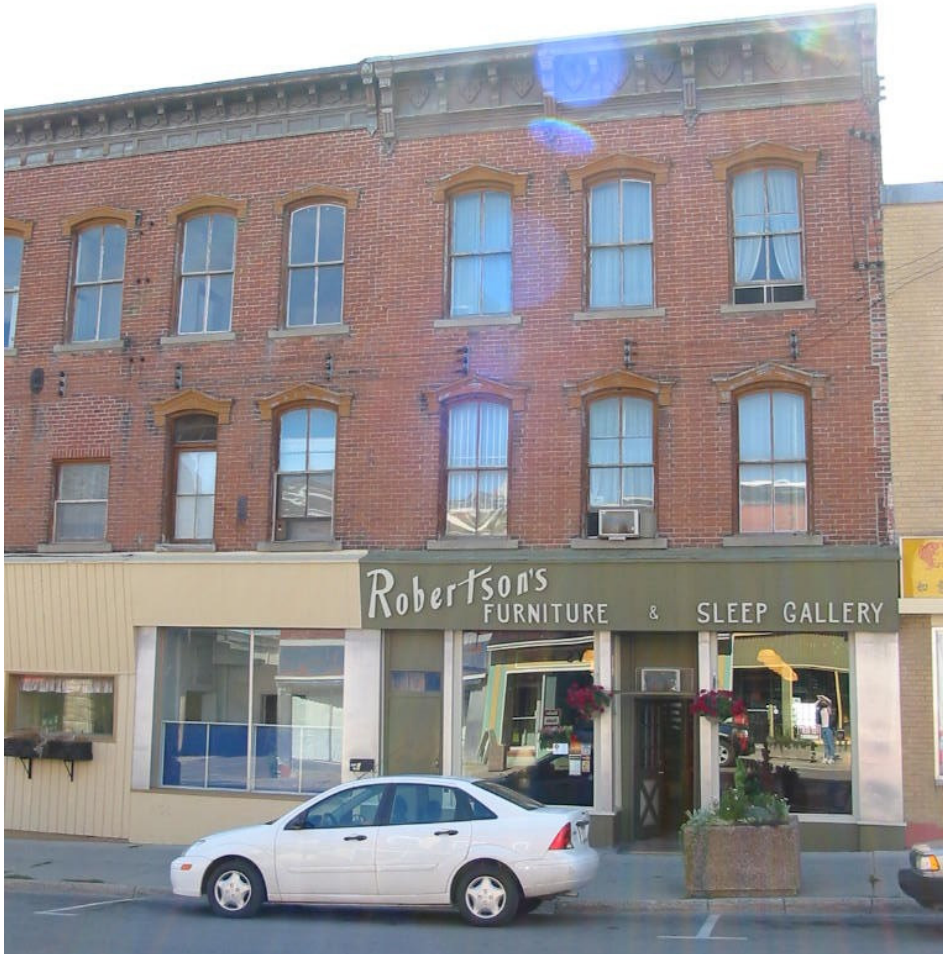
SOURCE: Carol Ruddy  
DATE: summer 2006

Three-storey, rectangular plan, flat-roofed red brick structure; three rectangular window openings with window hoods on the second and third level of the front elevation; window openings have masonry sills; the storefront has been renovated and has large display windows and a door that are contemporary in style; store entry is recessed; large sign panel over the display windows; elaborate building cornice with brackets.

Basic form intact; original window openings with hoods intact; the storefront has replacement windows and the sign panel area has been reworked.

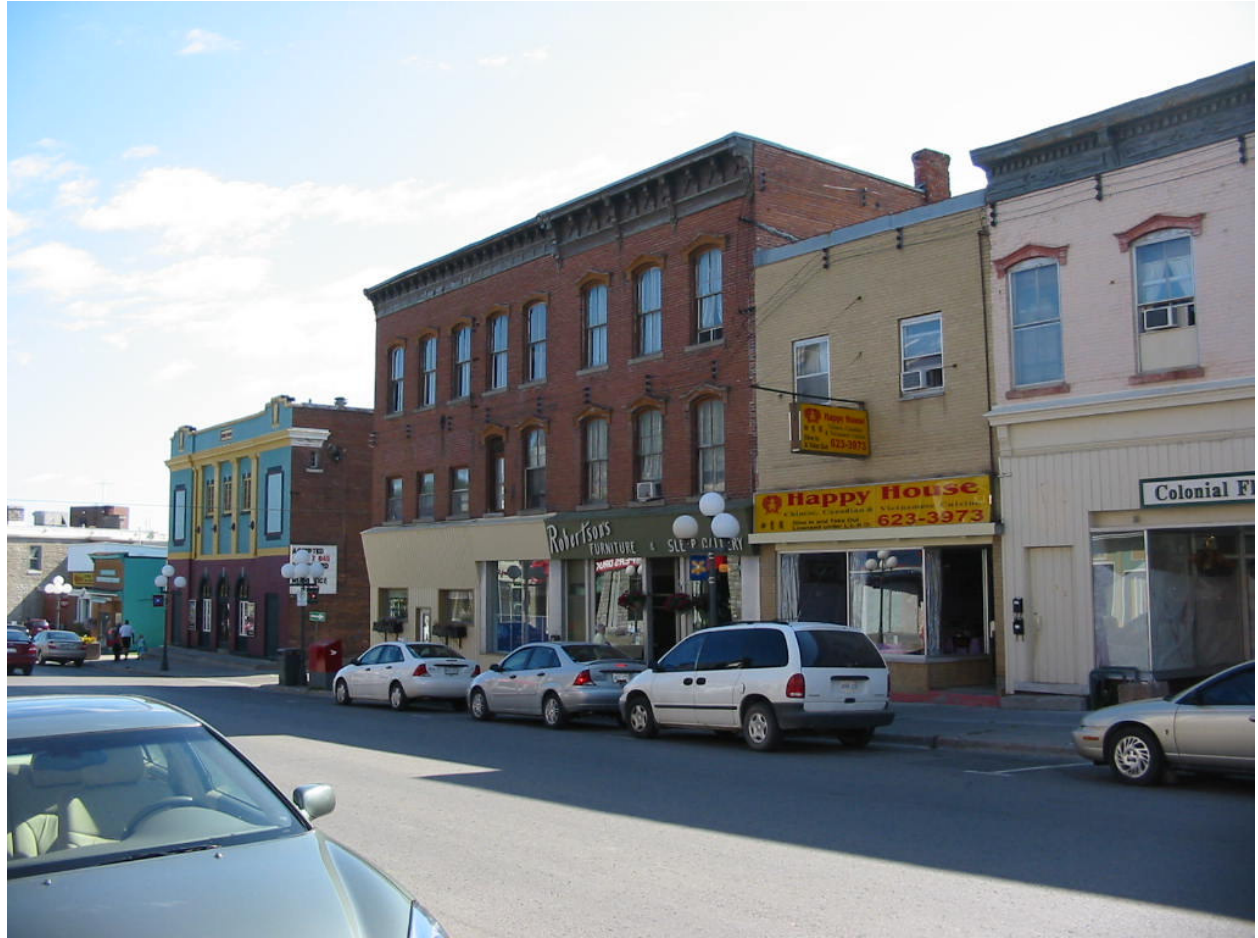
SOURCE: Carol Ruddy  
DATE: summer 2006

A compatible element in the streetscape.

The brick construction, window hoods, elaborate cornice with brackets and decorated frieze board are contributing elements to the streetscape.
