HERITAGE SURVEY AND EVALUATION FORM

MUNICIPAL ADDRESS: 88 – 94 John Street	BUILDING NAME: Cunningham Block		
LEGAL DESCRIPTION: Elgin Street South	LOT: Lot 25C	BLOCK:	PLAN:

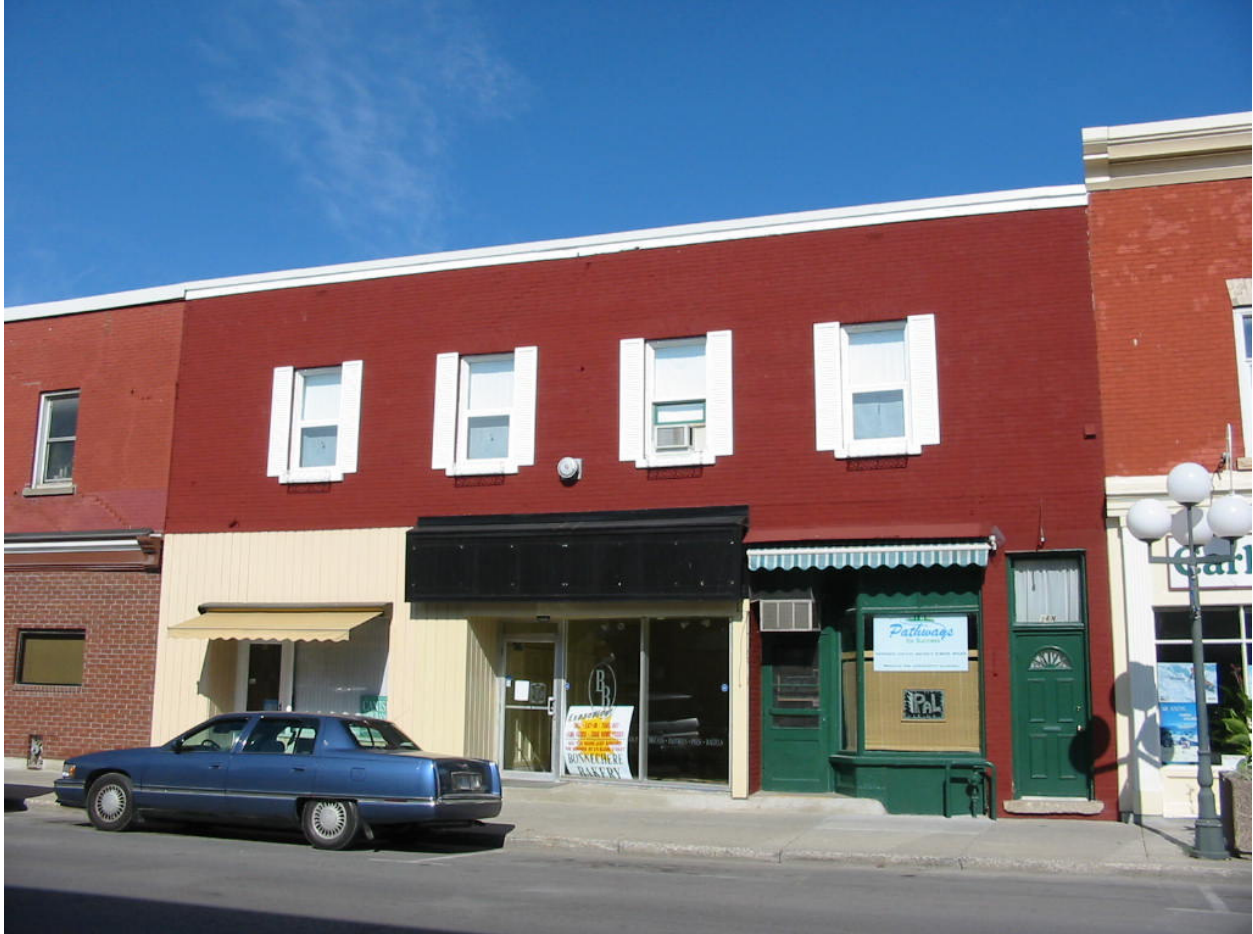
SOURCE: Carol Ruddy
DATE: summer 2006

Two-storey, flat-roofed, rectangular plan, brick cladding; storefronts have recessed entry areas; 88 generally maintains its original storefront organization, while the other two storefronts to the south have been reworked, with new storefront windows and doors and vertical siding painted green; four small rectangular window openings on the second level with replacement windows and contemporary shutters; no cornice.

Two of the three storefronts have been reworked; replacement windows and doors.

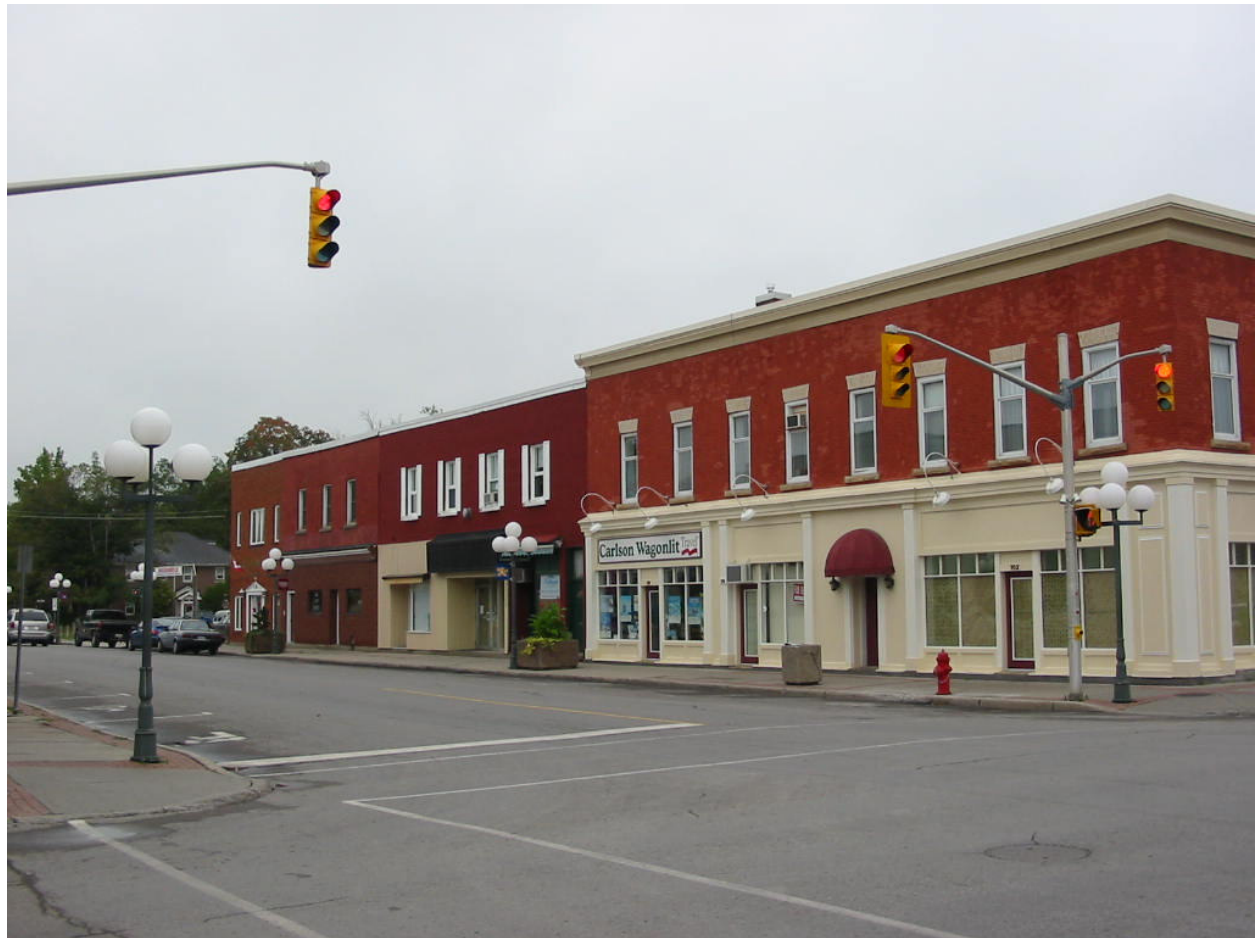
SOURCE: Carol Ruddy
DATE: summer 2006

Compatible with the streetscape character.

This later vernacular brick commercial building is restrained in decoration and is a compatible element in the streetscape.
